Innovations for Navigation Projects Research Program

Prototype Barge Impact Experiments, Allegheny Lock and Dam 2, Pittsburgh, Pennsylvania

January 2003

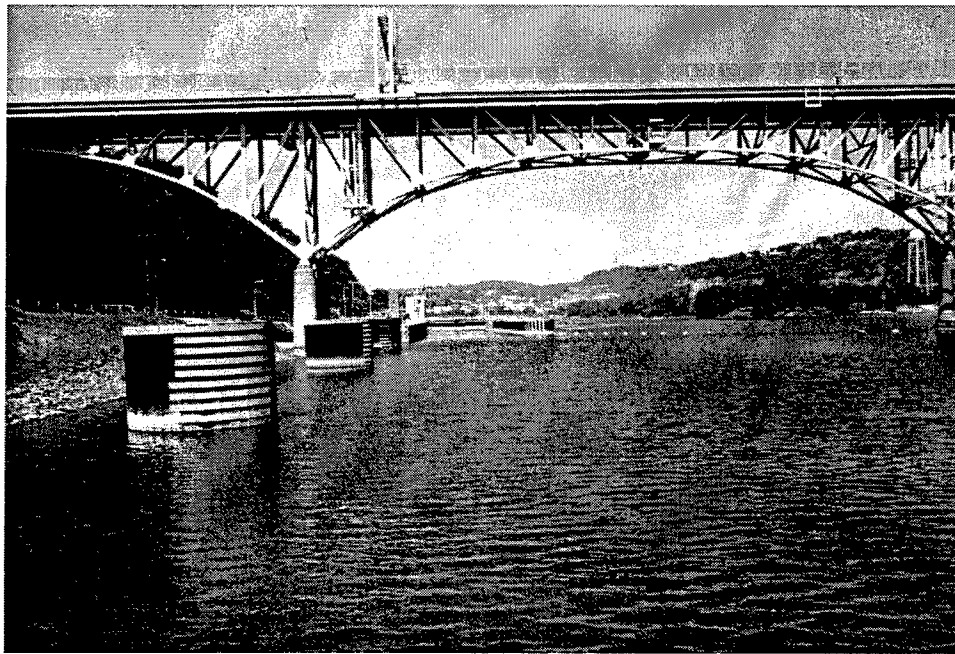
Figure 1. Looking downstream from Old Lock 2 to Lock and Dam 2

The site used for the experiments, Old Allegheny Lock 2, is just upstream from the existing Lock and Dam 2 on the Allegheny River, as shown in Figure 1. The Old Lock 2 was built in 1908 and was taken out of service in 1933 when the existing Lock and Dam 2 replaced it. The original chamber was 250 by 56 ft (76 by 17 m). The fixed-crest dam is from the upper guard wall to the right side of Figure 1. The old lock is approximately 1,500 ft (460 m) from the new Lock 2.

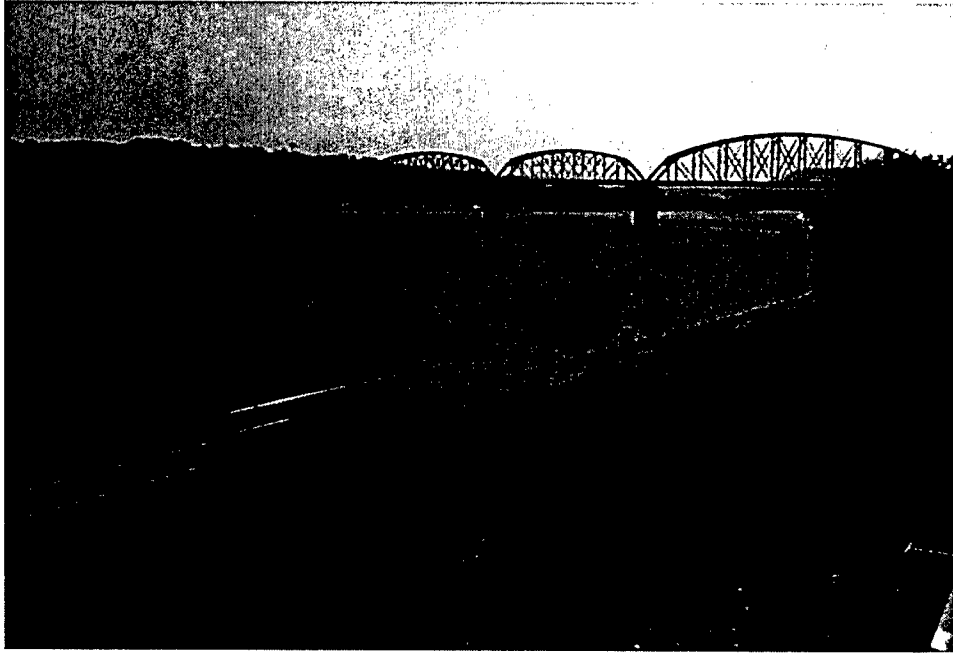
Figure 2. Old Lock and Dam 2, Allegheny River

The only sections that were left intact at the old lock are the upper guide wall, landside chamber wall, and lower guide wall. The two guide walls are founded on timber crib structures that have earthen fill behind them. The foundation for the lock chamber wall is not known but is suspected to be rock founded. The foundation and dimensions of the chamber wall were confirmed with soundings before the testing was commenced. Figure 2 shows the layout of the walls from the parking lot for Old Lock and Dam 2.

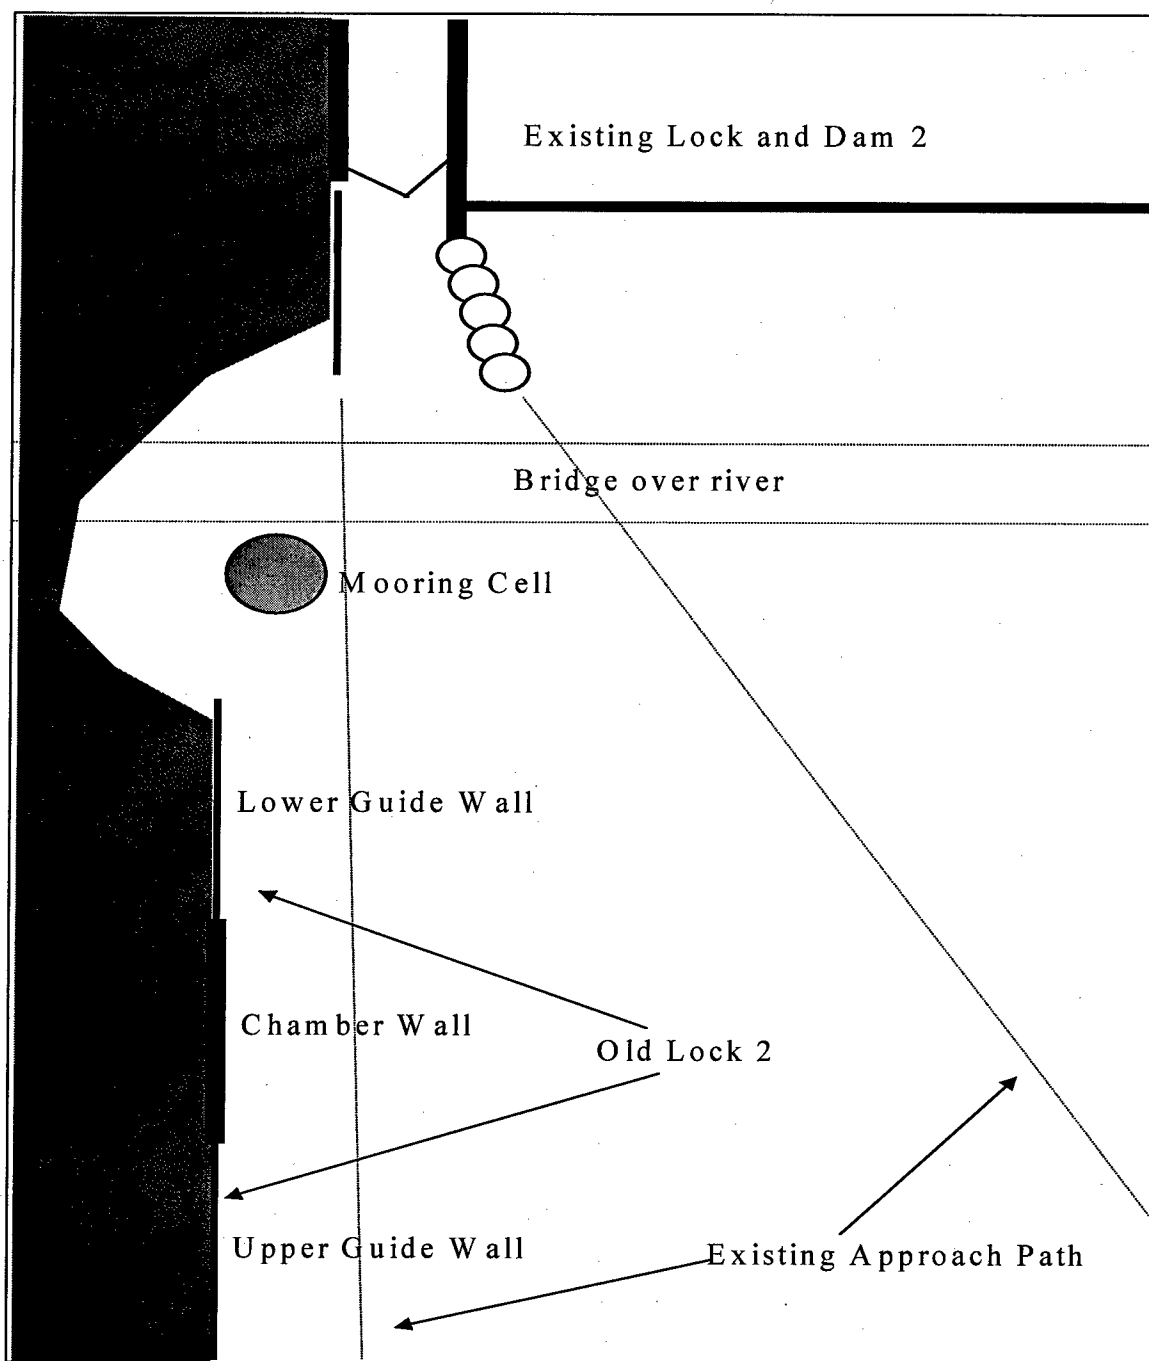
Figure 3. Schematic of old and existing Locks 2 (not to scale)

In the past few years, the old wall has been impacted numerous times by tows pushed by crosswinds across the approach into the existing Lock and Dam 2. Tows also currently use the wall to moor on while waiting for a locking vessel at Lock and Dam 2. In addition, the wall and esplanade have a very compact and solid backfill behind them, which seemed to be quite stable. The other parts of the lock were completely removed by blasting prior to the opening of the existing Lock and Dam 2. The gate sills for the Old Lock 2 are approximately 16 ft (5 m) under the water surface, according to recent sounding records. Schematic plan views of the existing and Old Lock 2 are shown in Figure 3 (note that the figure is not drawn to scale).

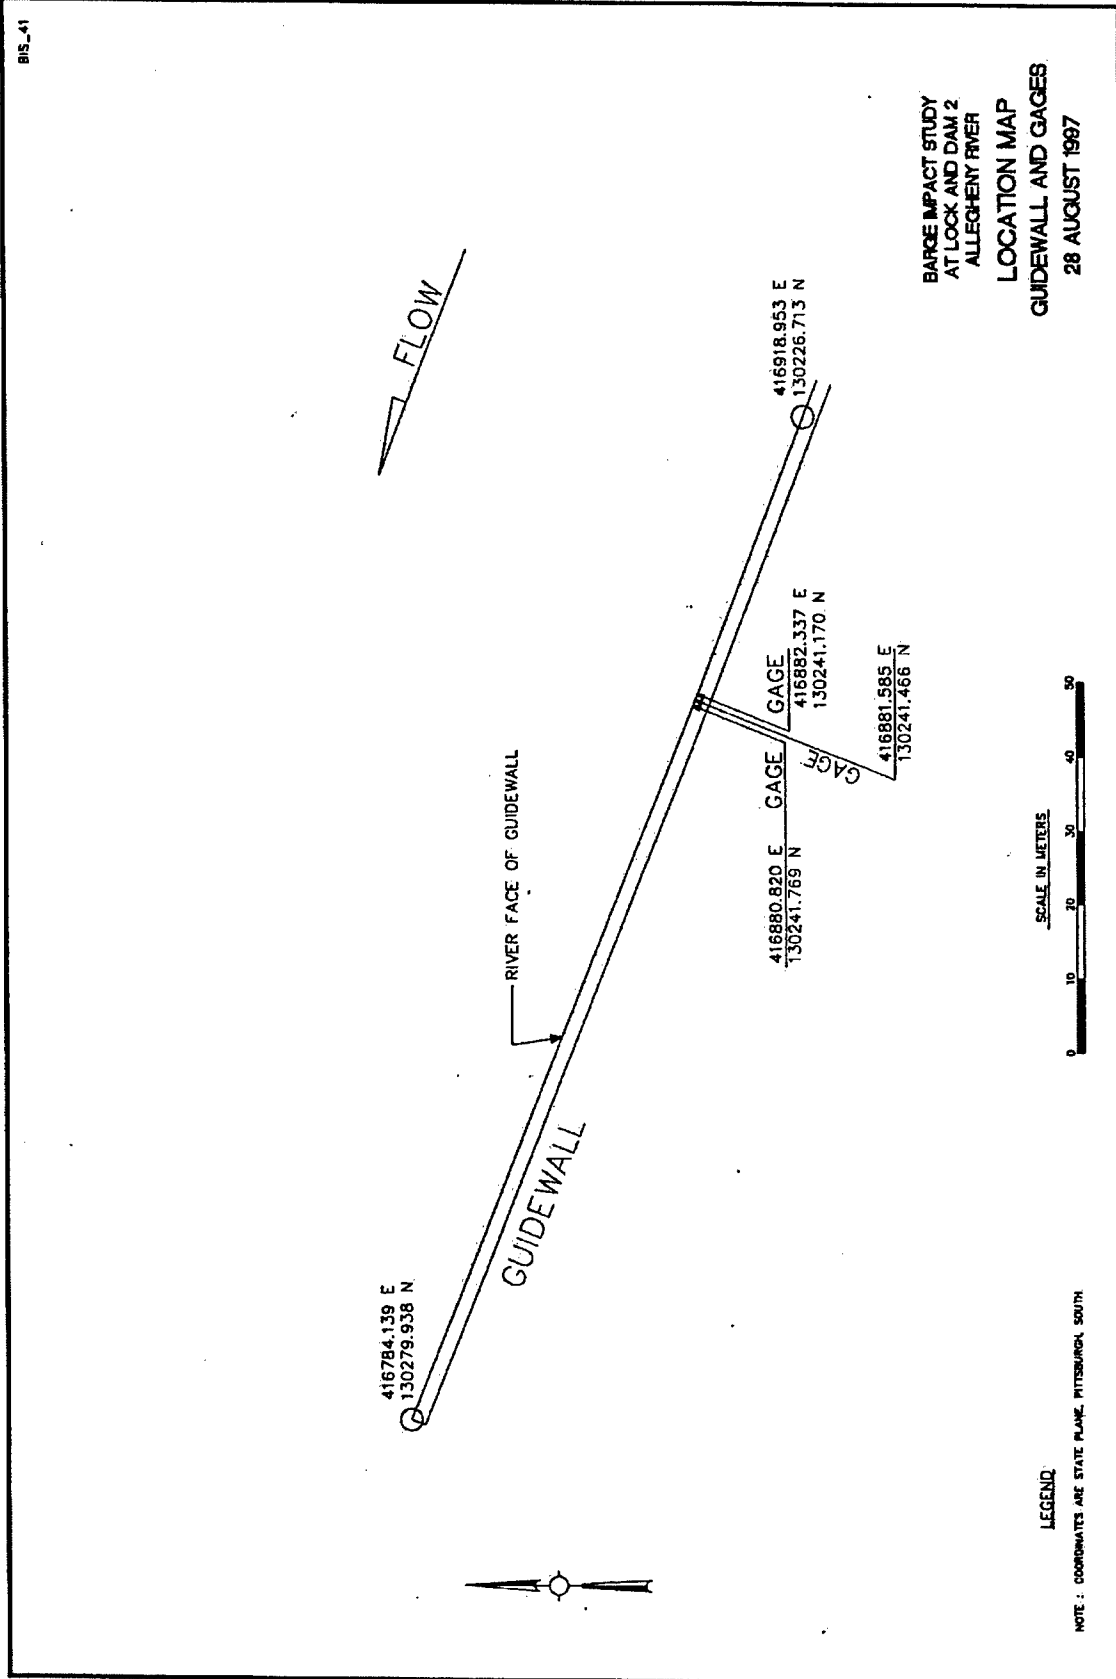
Figure 8. Diagram of page locations on the guide wall

Micro Measurements Model 2311 strain gage amplifiers were buffered through a 64-channel multiplex card, then interfaced to the PC through a 12-bit digitizer card. All software used for system control and presentation was developed in-house by ERDC personnel. The data acquisition system located below the pilothouse of the towboat is shown as Figure 7. The GPS locations of the instrumentation on the wall and on the barges are shown in Figures 8 and 9, respectively.

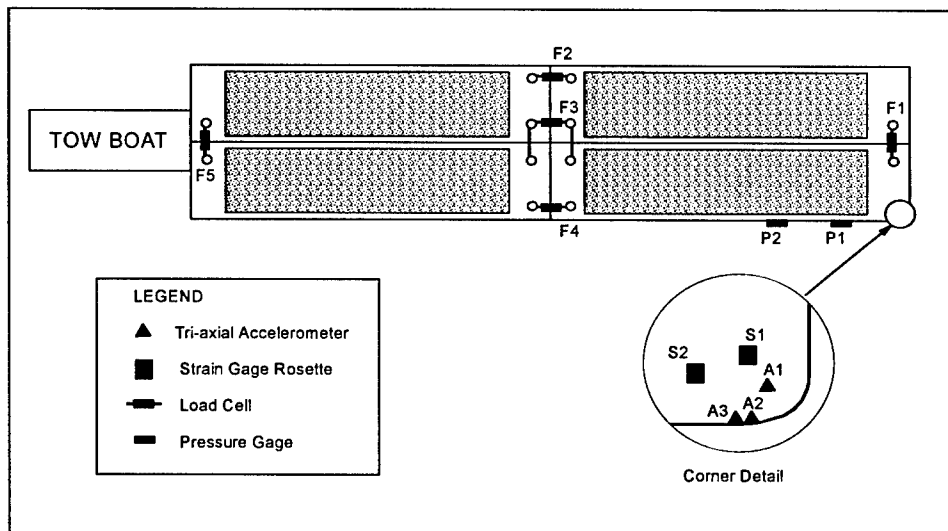
Figure 10. Layout of instrumentation on barges

Tri-axial accelerometer configurations were placed at three locations in the impact zone. It was intended that all three packages be mounted on a vertical center line at a 1-ft radius from the corner—one package on the top deck and the other two on gussets below the decking. However, the subject corner barge construction was inconsistent with typical hopper barges. The deck mount was located as planned, but the other packages had to be located on the interior hull, essentially on the impacted surface. This may have affected direct comparisons between accelerometer responses since the hull-mounted gages will receive the full shock of the impact that could induce undesirable resonance of the system. The locations of accelerometers are shown in Figure 10. Figure 11 shows the two under-deck accelerometers, and Figure 12 shows the accelerometer on the top deck.

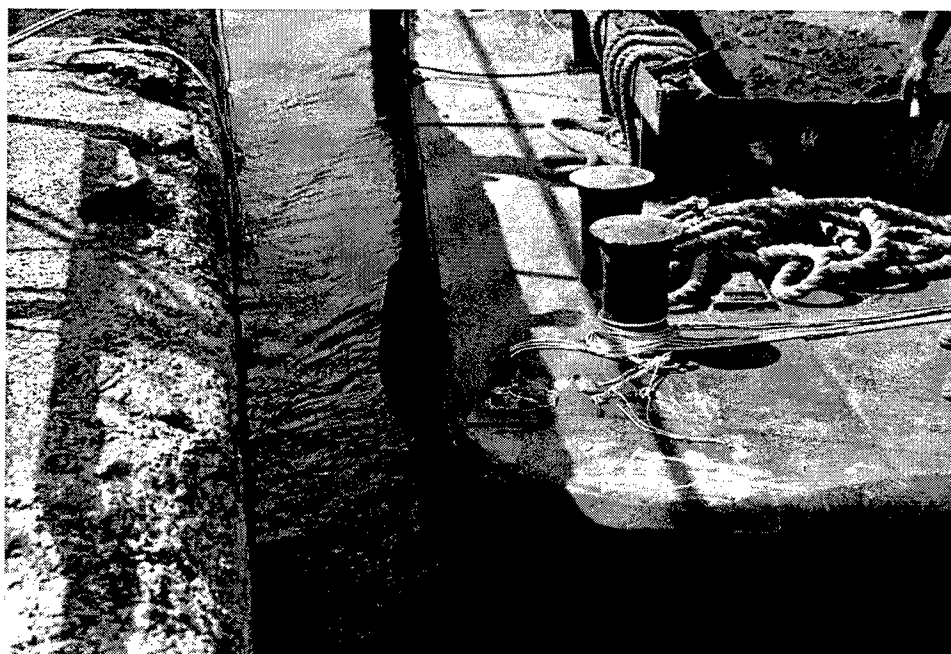
Figure 12. Accelerometer installed on top deck, located on the left side near edge of barge (gages are located at the two rusty spots on the barge deck, to the right of the accelerometer)

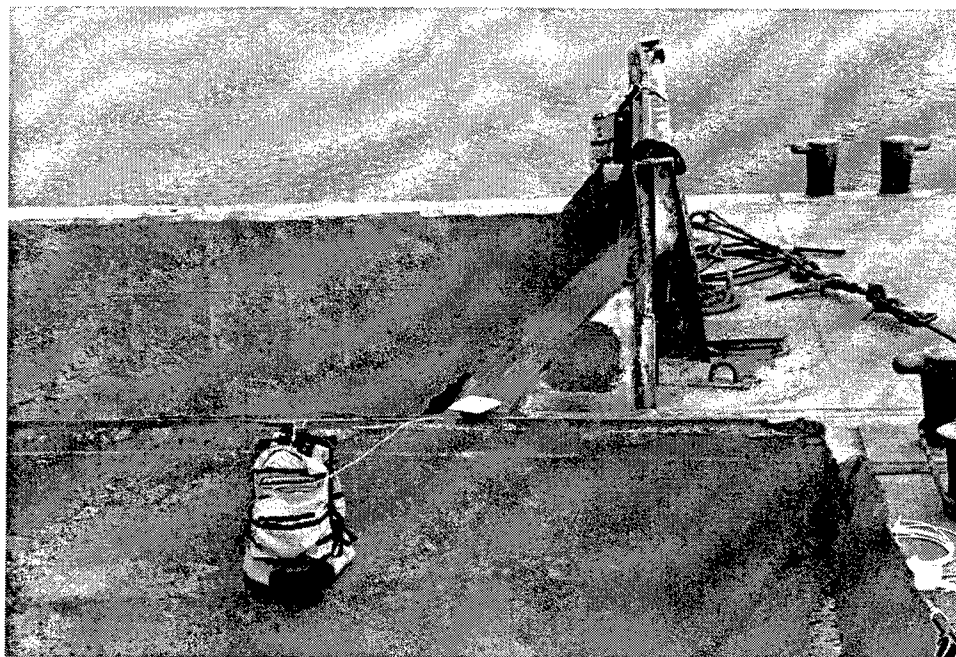
Figure 17. DGPS antennas and recorders on barges

The DGPS equipment included four Trimble 4000SSI dual-frequency receivers that were mounted to the tow to measure the angle, speed, and point of impact on the guide wall. The DGPS antennas were mounted on the barges using magnetic mounts, as shown in Figure 17. The antennas were positioned to minimize interference and provide the best possible satellite reception. The locations of the receivers are shown in Figure 9 as PT1, PT2, PT3, and PT4. A 4,000SSI receiver was placed on the riverside lock wall of Lock and Dam 2, Allegheny River, to record raw data for postprocessing. A static survey was conducted and postprocessed against the Continuous Operating Reference Station at Pittsburgh, PA (Pit1) to obtain an accurate position for the base unit and the lock wall.

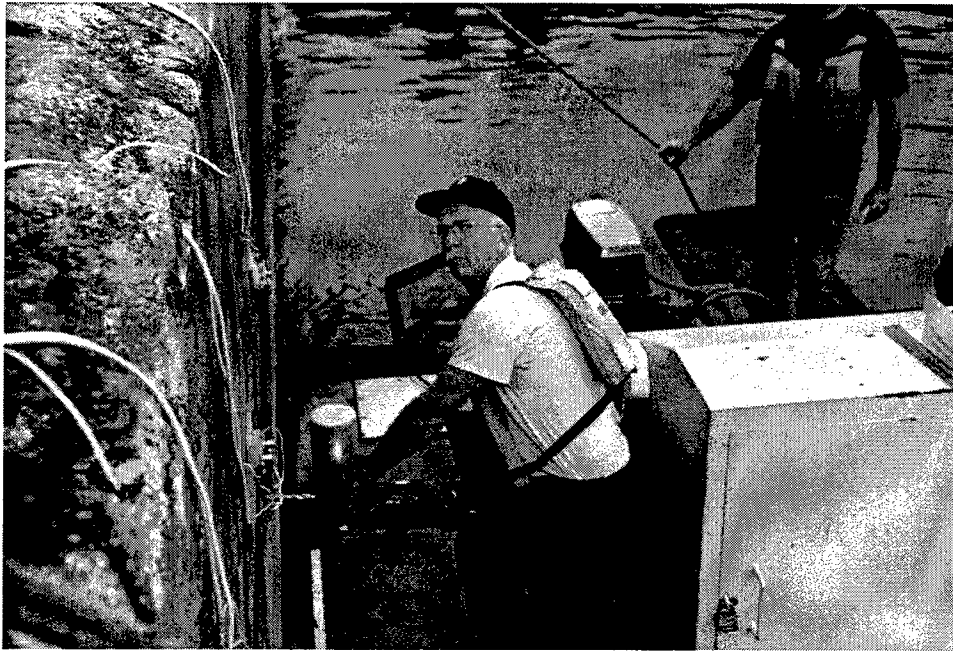
Figure 19. Installation of bumpers on lock wall

The UHMW bumpers were composed of a 2-in. (50-mm)-thick UHMW material with two 1-in. rubber backing pads. Each bumper was installed using five 1-in. anchor bolts. The holes for each anchor bolt were drilled into the concrete lock wall using qualified installation staff, as shown in Figure 19. Each bumper was installed separately to cover the impact zone. The final setup of the UHMW bumpers is shown in Figure 20.

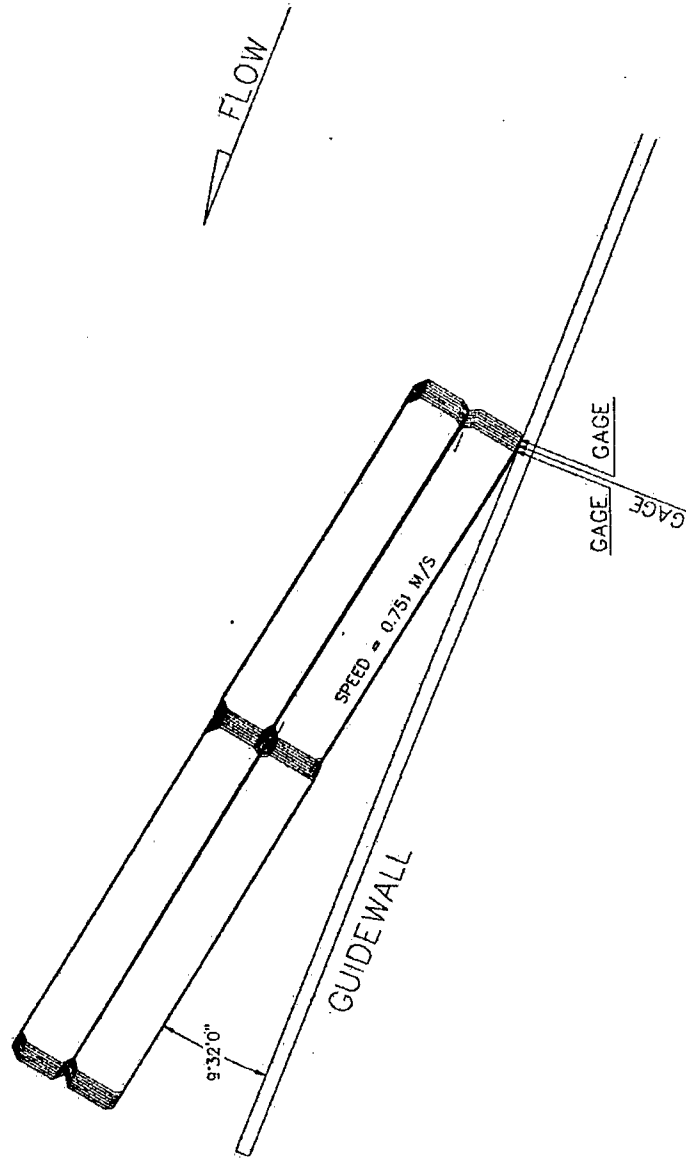
BARGE IMPACT STUDY
AT LOCK AND DAM 2
ALLEGHENY RIVER
BARGE ANGLE / SPEED
RUN 9 OF 36
28 AUGUST 1997

LEGEND
NOTE : BARGES LOADED TO 8.5 FT DRAFT
ANGLE, SPEED, AND POINT OF IMPACT
MEASURED USING GPS SURVEY TECHNOLOGY
ALL MEASUREMENTS ARE IN METERS

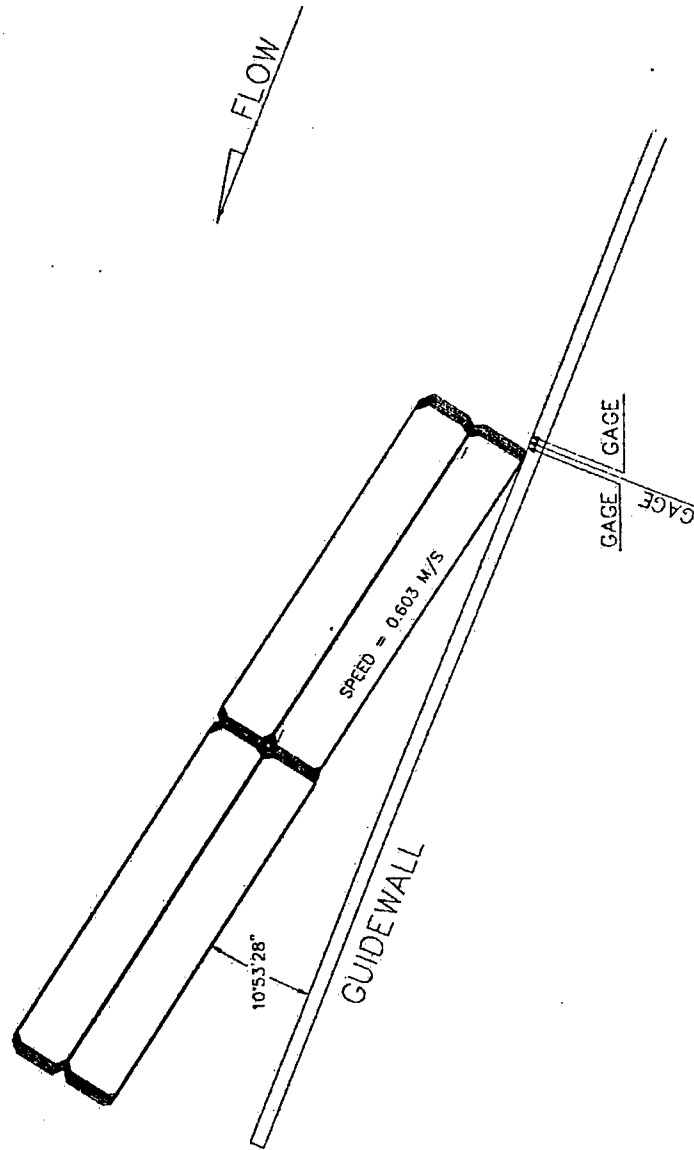
BARGE IMPACT STUDY
AT LOCK AND DAM 2
ALLEGHENY RIVER
BARGE ANGLE / SPEED
RUN 11 OF 36
28 AUGUST 1997

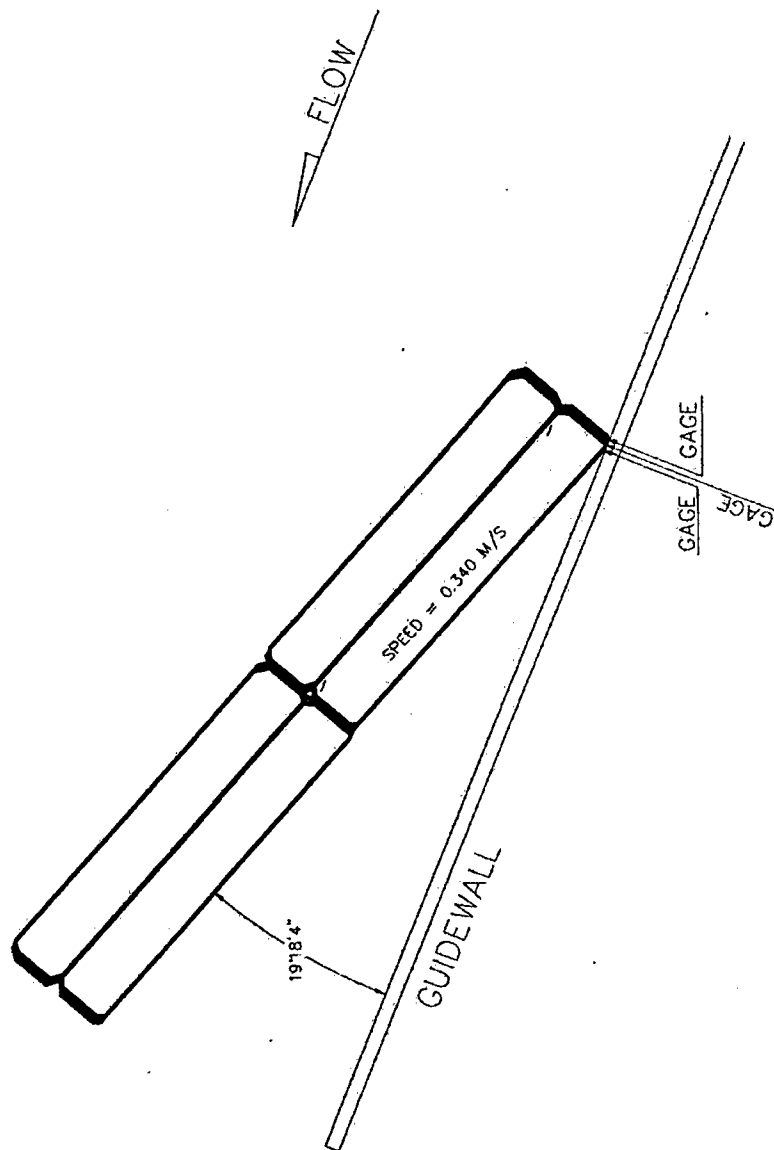
BARGE IMPACT STUDY
AT LOCK AND DAM 2
ALLEGHENY RIVER
BARGE ANGLE / SPEED
RUN 13 OF 36
28 AUGUST 1997

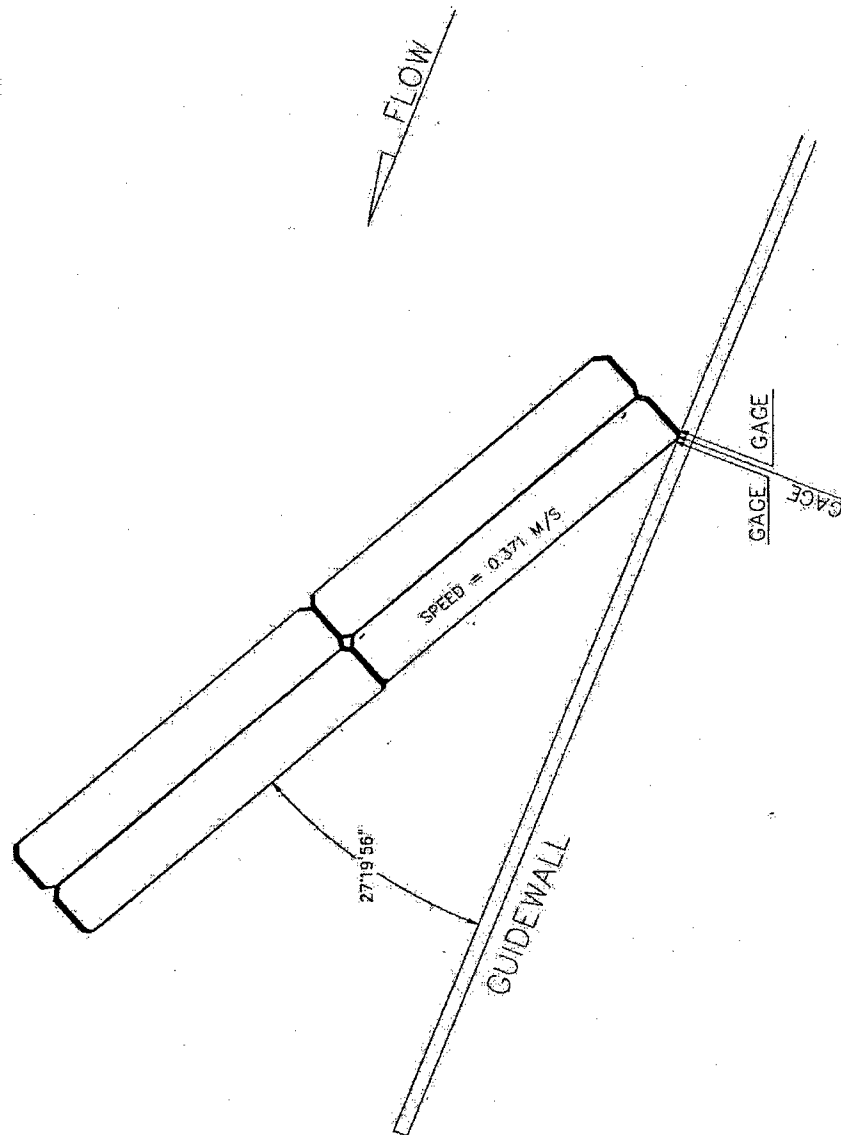
BARGE IMPACT STUDY
AT LOCK AND DAM 2
ALLEGHENY RIVER
BARGE ANGLE / SPEED
RUN 14 OF 36
28 AUGUST 1997

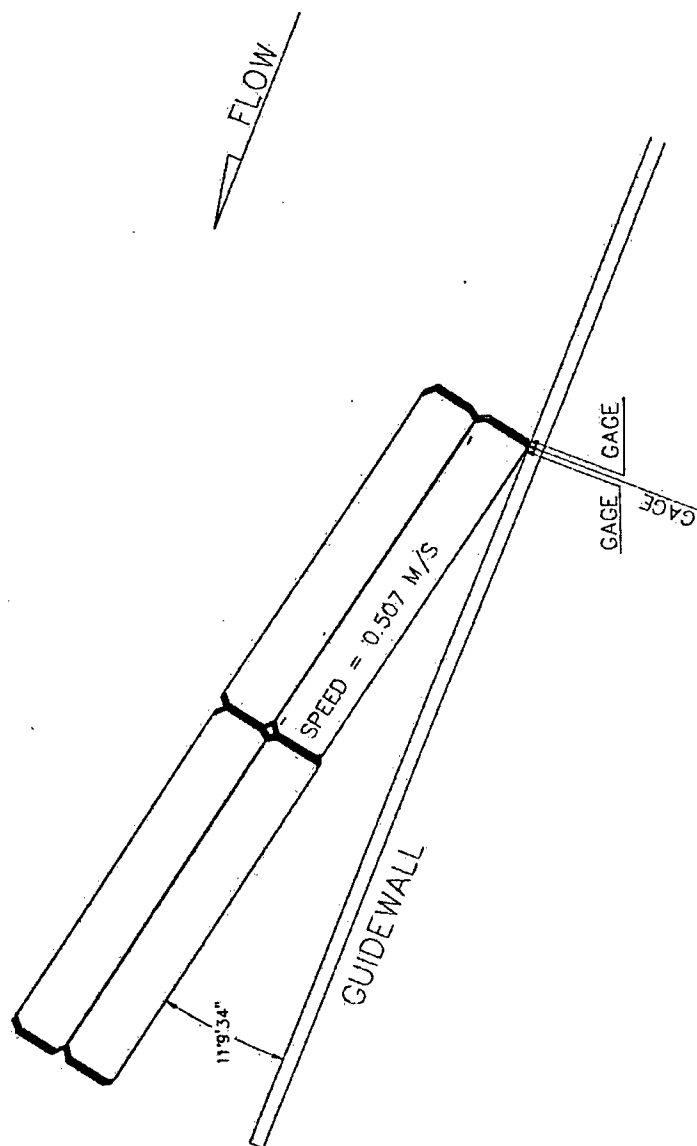
BARGE IMPACT STUDY
AT LOCK AND DAM 2
ALLEGHENY RIVER
BARGE ANGLE / SPEED
RUN 15 OF 36
28 AUGUST 1997

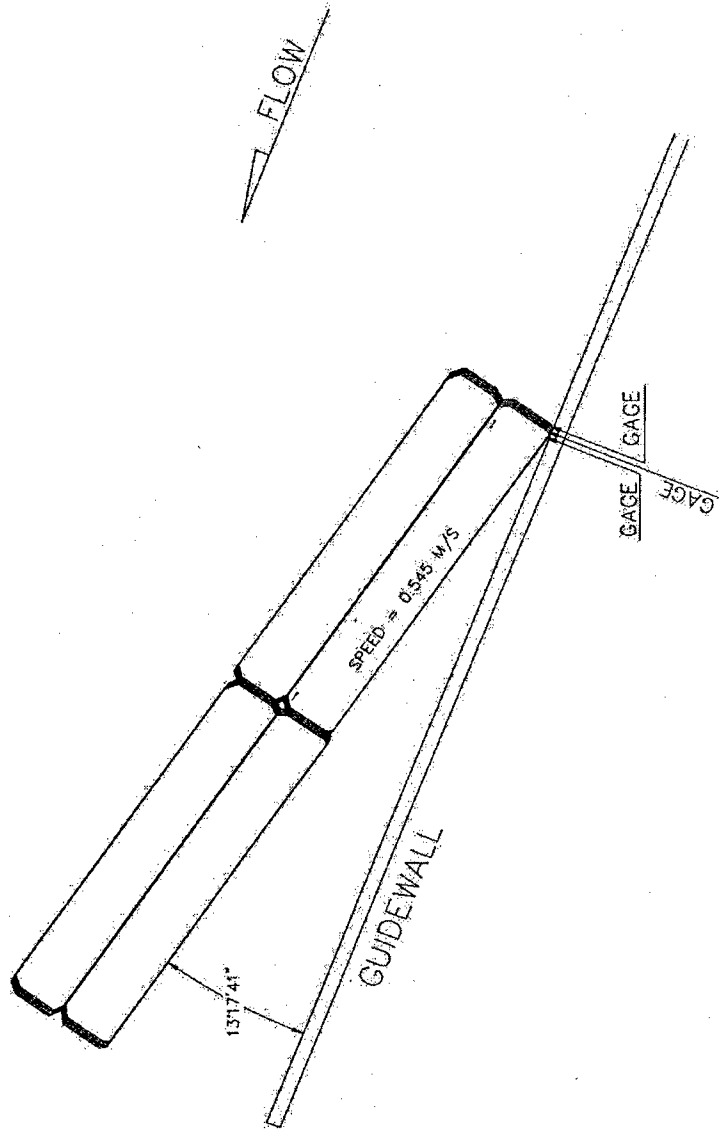
BARGE IMPACT STUDY
AT LOCK AND DAM 2
ALLEGHENY RIVER
BARGE ANGLE / SPEED
RUN 16 OF 36
28 AUGUST 1997

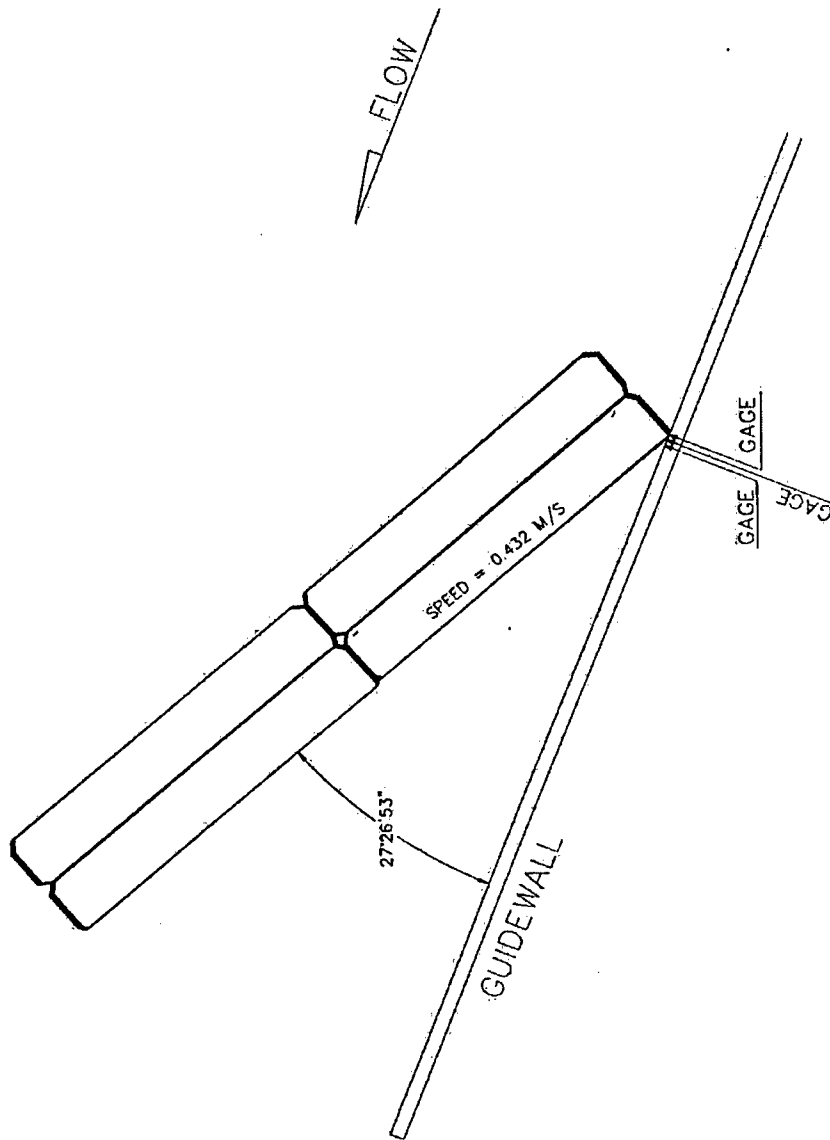
BARGE IMPACT STUDY
AT LOCK AND DAM 2
ALLEGHENY RIVER
BARGE ANGLE / SPEED
RUN 17 OF 36
28 AUGUST 1997

LEGEND
NOTE : BARGES LOADED TO 8.5 FT DRAFT
ANGLE, SPEED, AND POINT OF IMPACT
MEASURED USING GPS SURVEYING TECHNOLOGY
ALL MEASUREMENTS ARE IN METERS

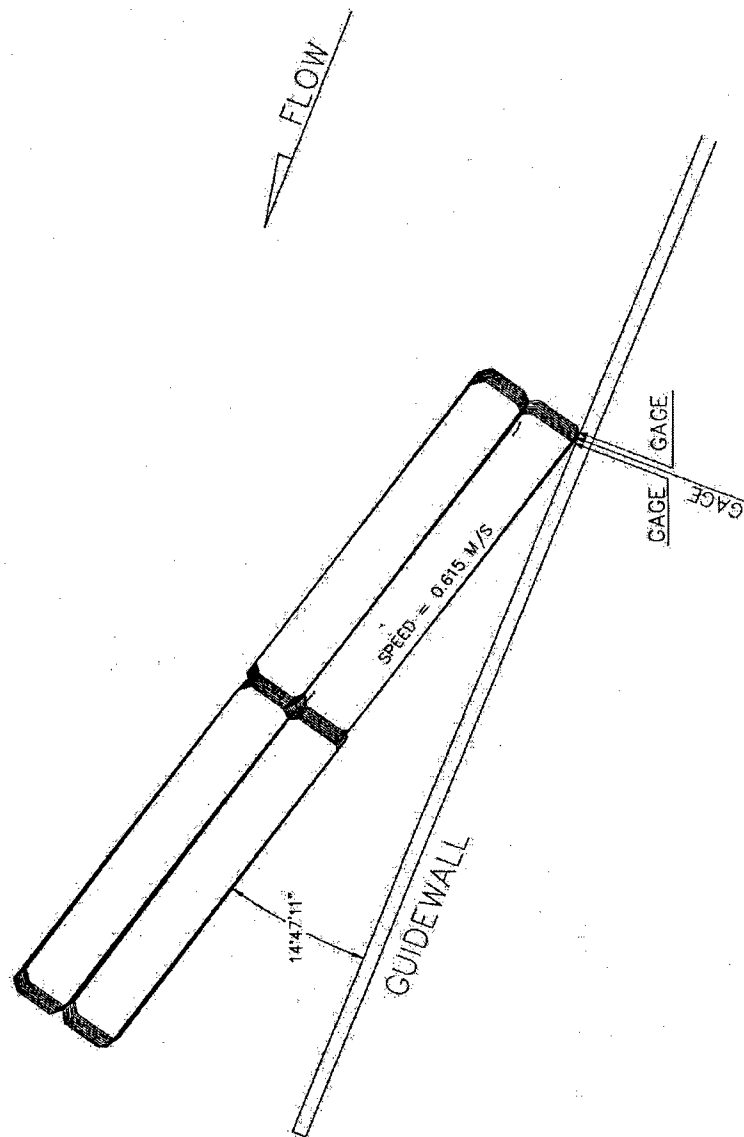
BARGE IMPACT STUDY
AT LOCK AND DAM 2
ALLEGHENY RIVER
BARGE ANGLE / SPEED
RUN 18 OF 36
28 AUGUST 1997

LEGEND
NOTE : BARGES LOADED TO 8.5 FT DRAFT
ANGLE, SPEED, AND POINT OF IMPACT
MEASURED USING GPS SURVING TECHNOLOGY
ALL MEASUREMENTS ARE IN METERS

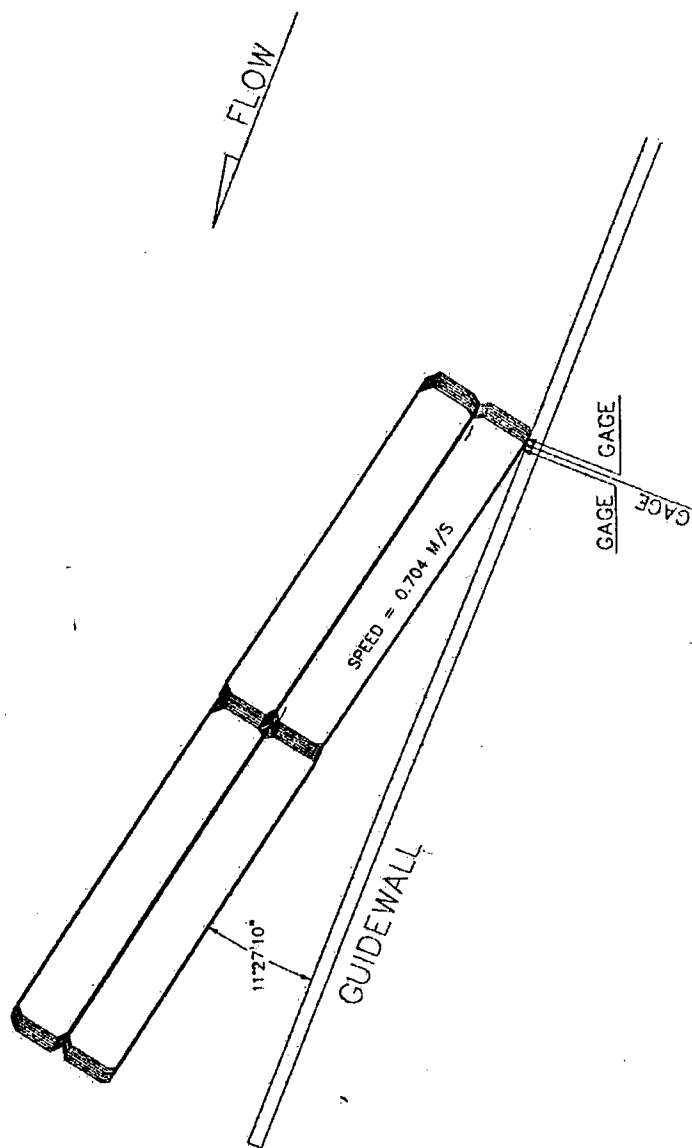
BARGE IMPACT STUDY
AT LOCK AND DAM 2
ALLEGHENY RIVER
BARGE ANGLE / SPEED
RUN 19 OF 36
28 AUGUST 1997

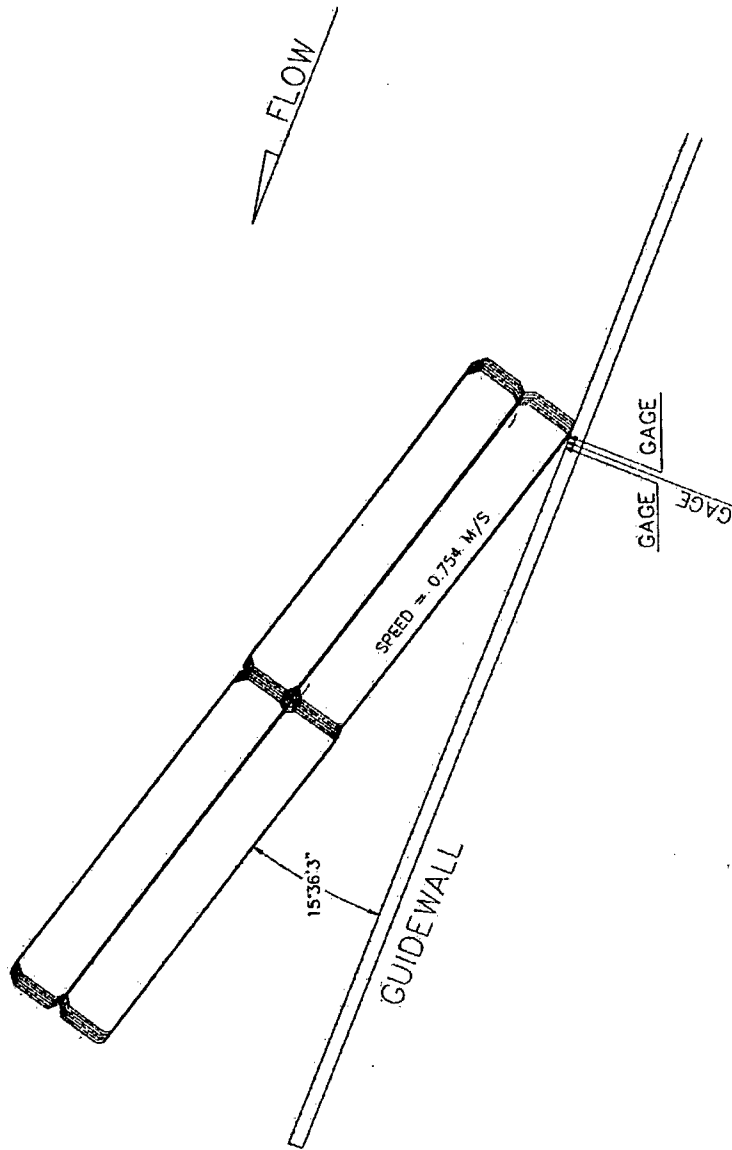
BARGE IMPACT STUDY
AT LOCK AND DAM 2
ALLEGHENY RIVER
BARGE ANGLE / SPEED
RUN 21 OF 36
28 AUGUST 1997

LEGEND
NOTE: BARGES LOADED TO 8.5 FT DRAFT
ANGLE, SPEED, AND POINT OF IMPACT
MEASURED USING GPS SURVING TECHNOLOGY
ALL MEASUREMENTS ARE IN METERS

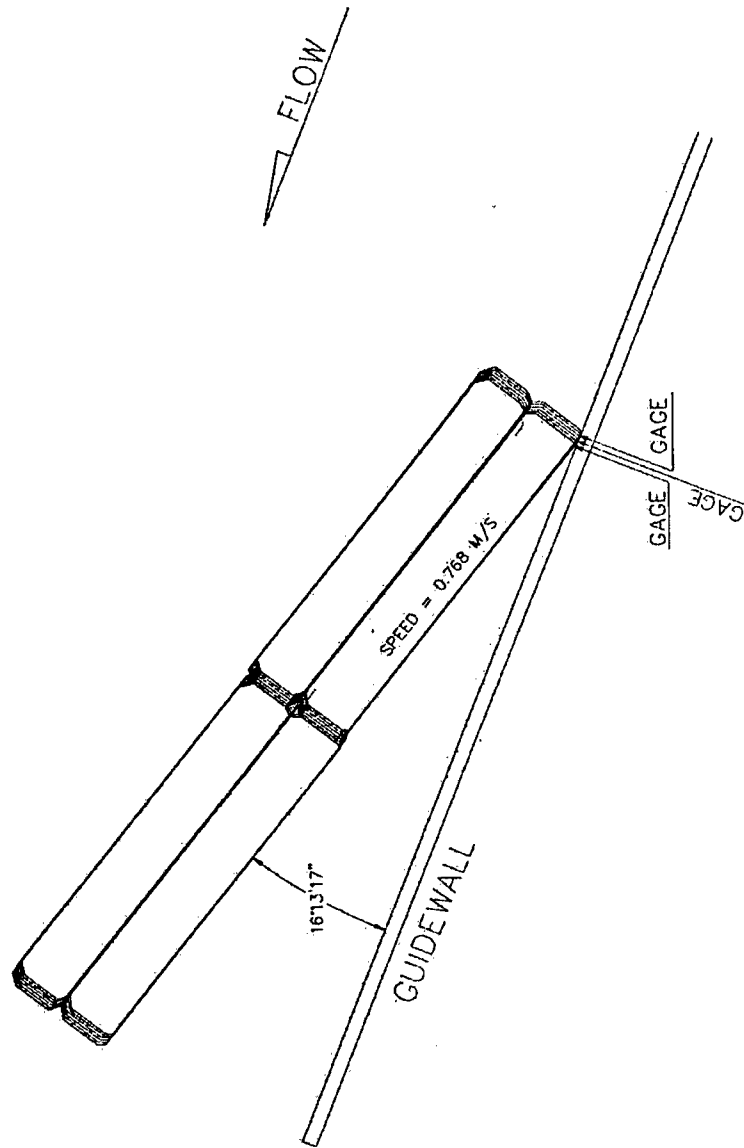
BARGE IMPACT STUDY
AT LOCK AND DAM 2
ALLEGHENY RIVER

BARGE ANGLE / SPEED
RUN 23 OF 36
28 AUGUST 1997

NOTE: BARGES LOADED TO 6.5 FT DRAFT
ANGLE, SPEED, AND POINT OF IMPACT
MEASURED USING GPS SURVING TECHNOLOGY
ALL MEASUREMENTS ARE IN METERS

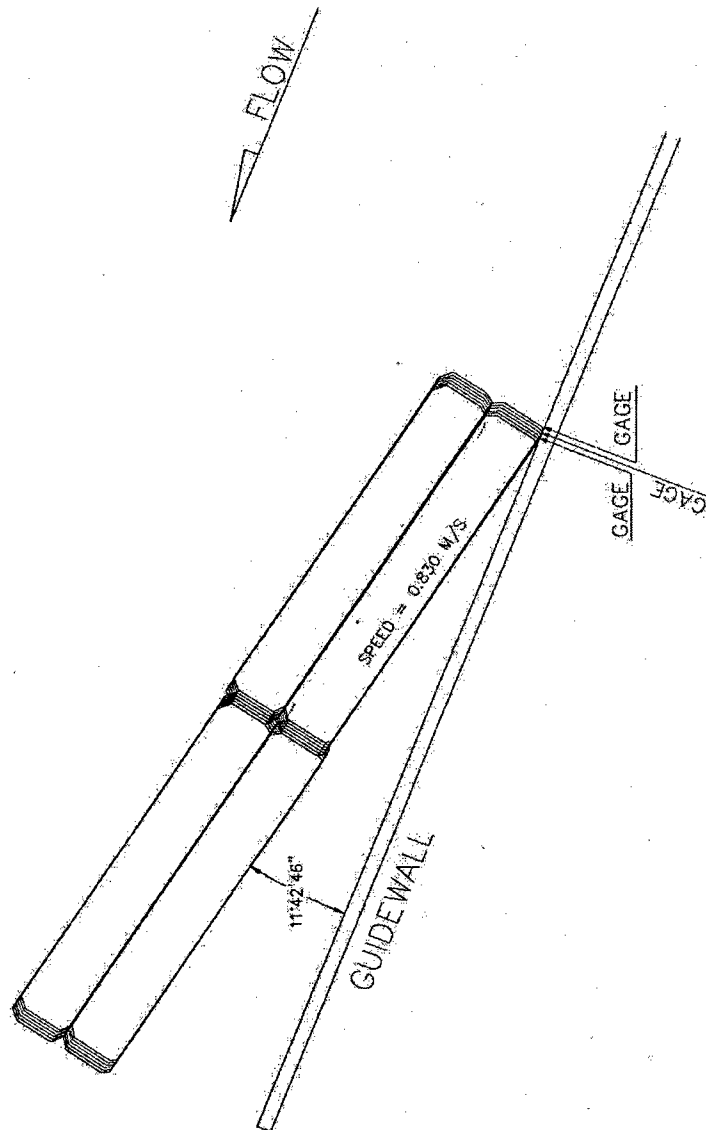
BARGE IMPACT STUDY
AT LOCK AND DAM 2
ALLEGHENY RIVER
BARGE ANGLE / SPEED
RUN 24 OF 36
28 AUGUST 1997

NOTE: BARGES LOADED TO 4.5 FT DRAFT
ANGLE, SPEED, AND POINT OF IMPACT
MEASURED USING GPS SURVING TECHNOLOGY
ALL MEASUREMENTS ARE IN METERS

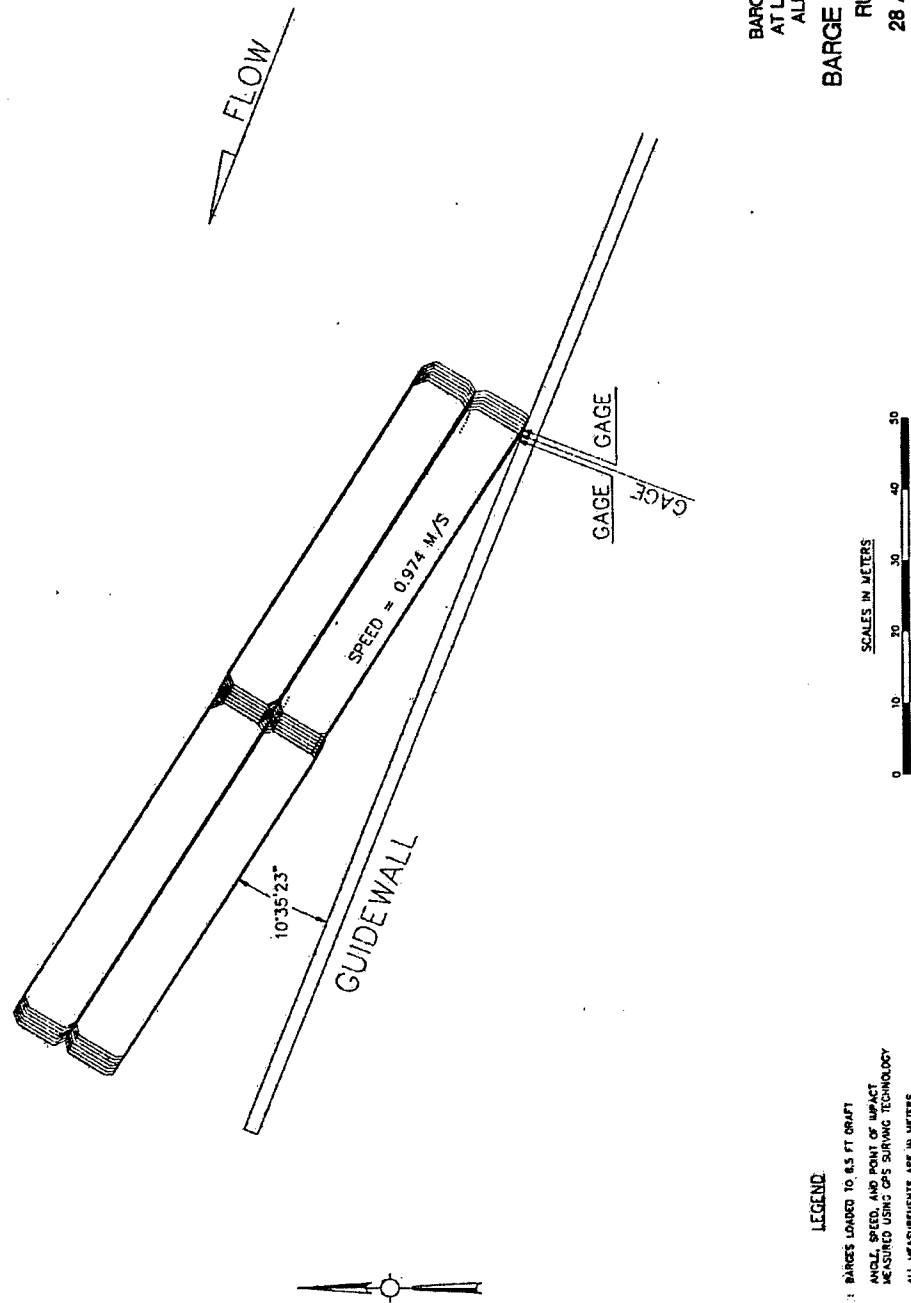
BARGE IMPACT STUDY
AT LOCK AND DAM 2
ALLEGHENY RIVER
BARGE ANGLE / SPEED
RUN 25 OF 36
28 AUGUST 1997

LEGEND
NOTE: BARGES LOADED TO 8.5 FT DRAFT
ANGLE, SPEED, AND POINT OF IMPACT
ACQUIRED USING GPS SURVEY TECHNOLOGY
ALL MEASUREMENTS ARE IN METERS

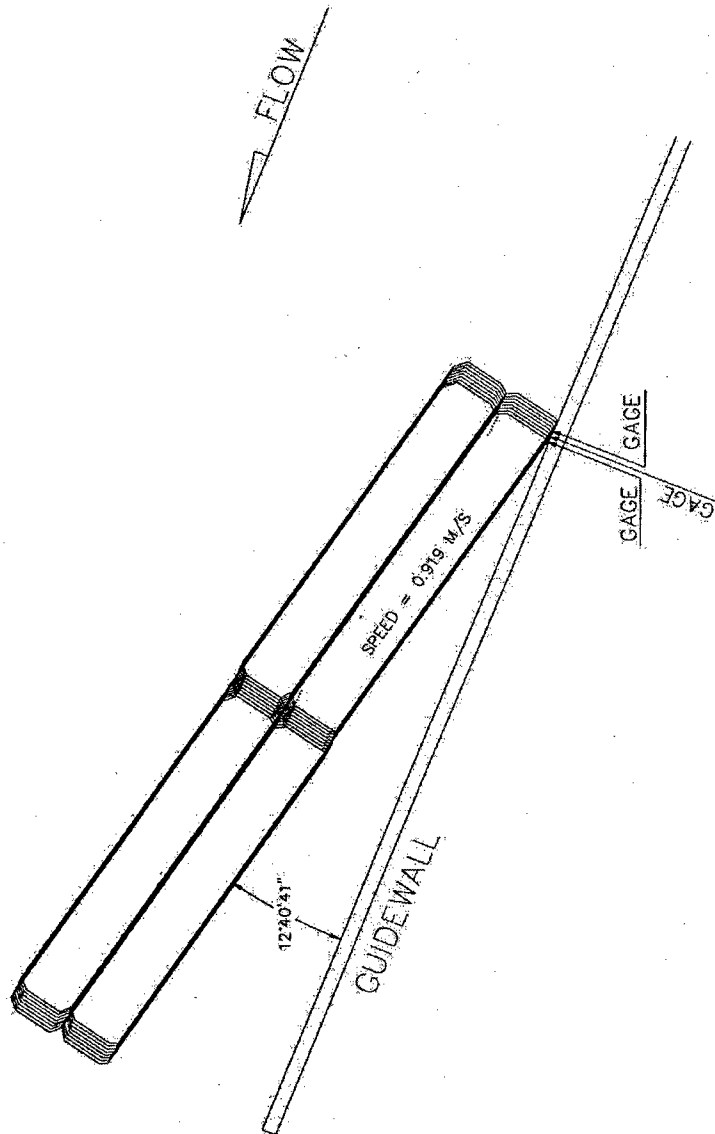
BARGE IMPACT STUDY
AT LOCK AND DAM 2
ALLEGHENY RIVER
BARGE ANGLE / SPEED
RUN 28 OF 36
BUMPER IN PLACE

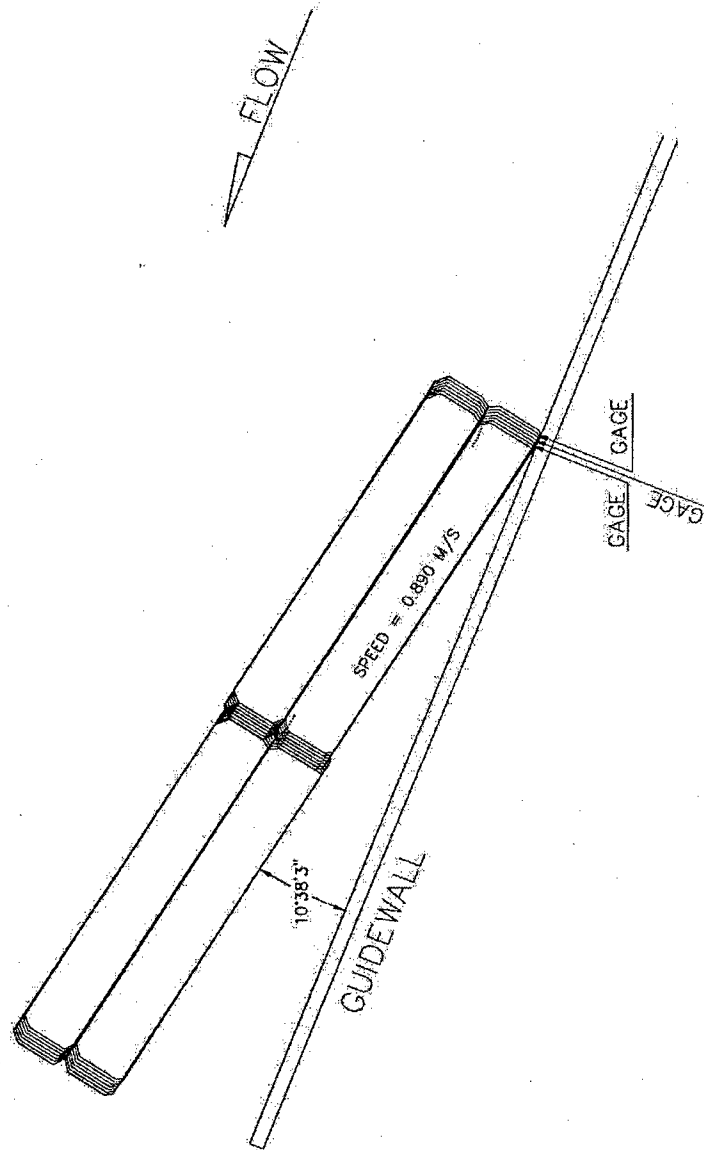
BARGE IMPACT STUDY
AT LOCK AND DAM 2
ALLEGHENY RIVER
BARGE ANGLE / SPEED
RUN 30 OF 36
BUMPER IN PLACE

LEGEND
NOTE: BARGES LOADED TO 8.5 FT DRAFT
ANGLE, SPEED, AND POINT OF IMPACT
MEASURED USING GPS SURVING TECHNOLOGY
ALL MEASUREMENTS ARE IN METERS

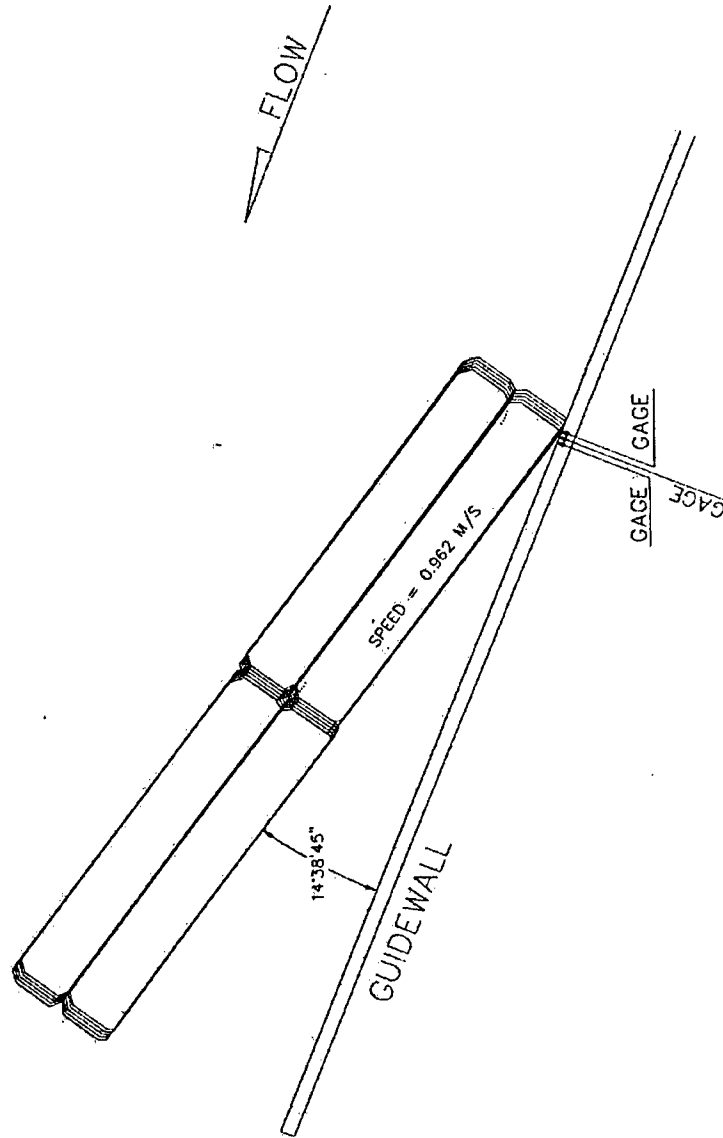
BARGE IMPACT STUDY
AT LOCK AND DAM 2
ALLEGHENY RIVER
BARGE ANGLE / SPEED
RUN 31 OF 36
BUMPER IN PLACE

LEGEND
NOTE: BARGES LOADED TO 8.5 FT DRAFT.
ANGLE, SPEED, AND POINT OF IMPACT
RECORDED USING GPS SURVEYING TECHNOLOGY
ALL MEASUREMENTS ARE IN METERS
